Manhole Inspection Summary

Manhole # S55E__005MH

Location Address: **110 EATON-FAGLEY-ALLEY** Cross Street: **E LOMBARD ST**

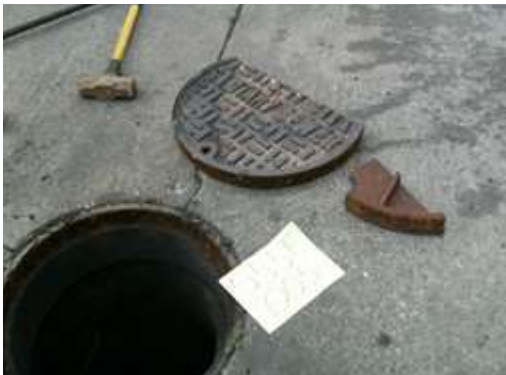
MISC.

BROKE AND REPLACED COVER

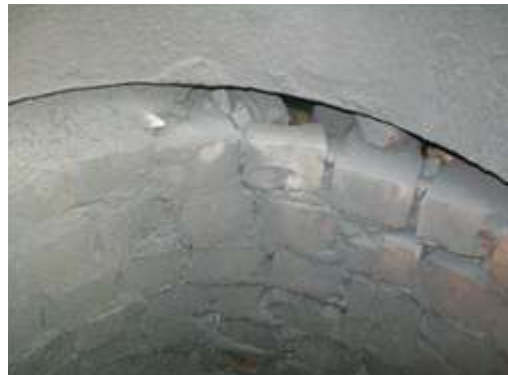
Defect 2

Frame Offset: **2** (in.) Condition: ☒ Sound ☐ Cracked ☐ Leaks

FRAME OFFSET

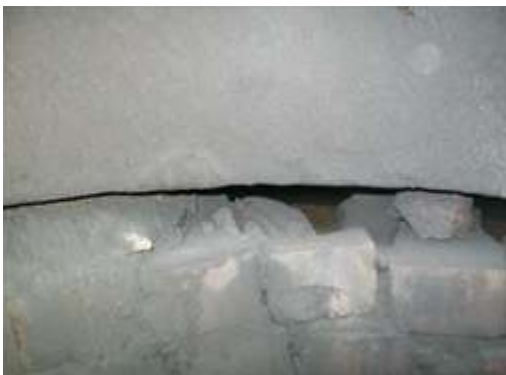
Defect 1

Chimney / Frame Adjustment ☒ Exists Material: **Brick** ☐ Parged Height: **3** (in.)

Condition: ☐ Sound ☐ Cracked ☐ Root Intrusion ☐ Loose Brick ☒ **Deteriorated**

DETERIORATED CHIMNEY BRICKS

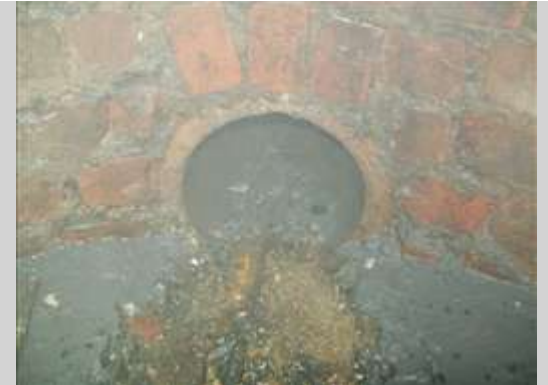
12 O'Clock Outflow

8 in. Circular Gravity Sewer
Pipe Out @ 12 O'Clock

Invert Depth: **7.20** (ft.) Flow Characteristics: **Slow**

Infiltration: **None** Pipe Seal Cond: **Sound**
